Not All Stainless Steel Resists Corrosion

Sauereisen's Solution Protected a Stainless Steel Structure From Future Degradation

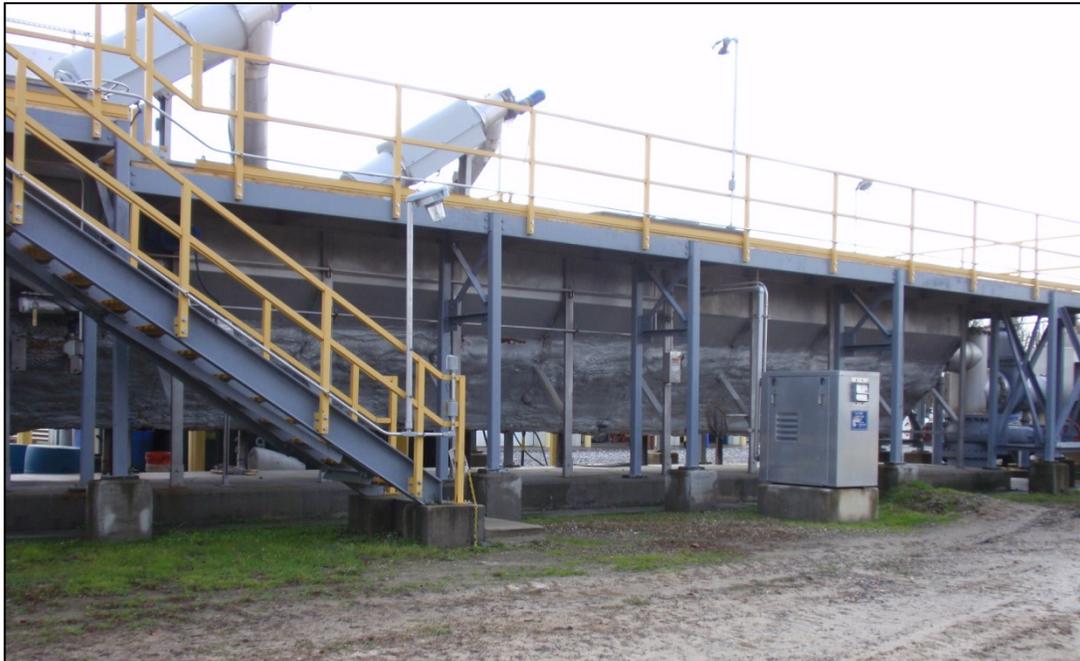
Figure 1 Above grade stainless steel headworks tank at Logan Township MUA

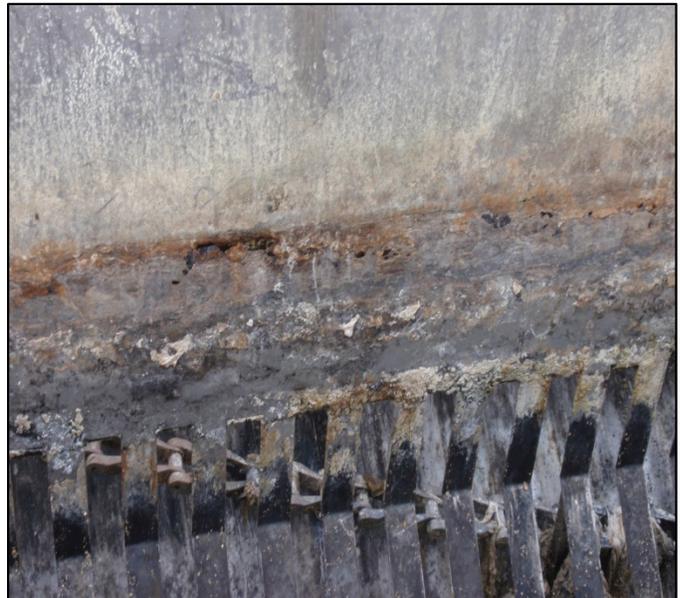
Testing by Logan Township MUA was very minimal; however the sulfides test that were run showed low levels of sulfides. The investigation revealed that the tank was constructed of 304 grade stainless steel, which is not sufficient enough to provide the necessary protection required in this environment. Stainless steel is a corrosion-resistant steel alloy with a minimum of 10.5% chromium content by weight. 304 stainless steel is the most common austenite

Figure 2 Stainless steel tank wall with holes resulting from MIC.

steel with a composition of 18% chromium and 8% nickel and is not supposed to corrode or rust like that of common carbon steel. However, under specific conditions such as 100% O₂ environments, or containment with poor circulation, as is the case at Logan Township MUA, 304 stainless steel can corrode. Higher grade stainless, with sufficient chromium, will form a passive film of chrome-oxide on the surface to prevent attack and penetration into the steel substrate below in the form of iron-oxide. A higher grade of stainless steel could have prevented this corrosion from occurring.

210X was chosen because of its chemical resistance, elongation and abrasion resistant properties. “The No. 210X provides increased elongation, a lower permeability, and greater abrasion resistance than most other epoxy and urethane wastewater coatings on the market,” Lattin said. Aulffo Painting spray applied the SewerGard™ No. 210X in two coats, totaling 60 mils to withstand the corrosion and abrasion from solids and debris in the wastewater. The walls were coated 12” below the low waterline up to the top of the tank, the area most susceptible to the corrosive effects of the MIC. Gary Aulffo, president of Aulffo Painting stated “we have been working with Corrosion Technology Systems and Sauereisen for over 10 years, and over the course of countless projects they have proven to provide the highest quality products, complemented by excellent customer service.” Another preventative measure taken by the Logan Township MUA was to replace the closed hatch tops with open grates to minimize the accumulation of destructive hydrogen sulfide gases in the vapor zone.

Jon Lattin, Sauereisen’s representative in New Jersey, called in Aulffo Painting of Minotola, NJ to offer their expertise on tank rehabilitation to perform the tank refurbishment. “We constantly strive to provide long lasting service and affordability to our customers and in this unique situation we had to react quickly with a solution to minimize Logan Township MUA’s tank downtime,” said Jon Lattin. Logan Township MUA arranged for a separate contractor to weld in new sections of stainless steel in areas that were compromised. The stainless steel was then abrasive blasted by Aulffo Painting to achieve a 3-4 mil profile (SSPC-5 White Metal blast).

The lining material selected to protect the structure was Sauereisen’s SewerGard™ No. 210X. The No.

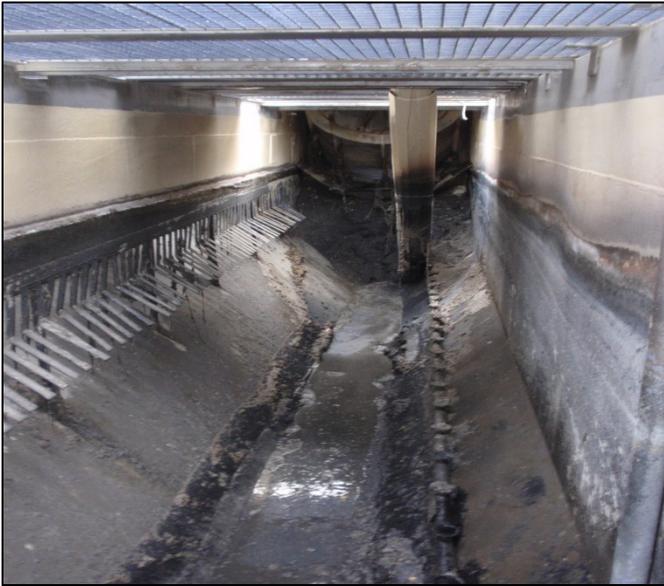
Figure 3 View looking down the tank after six months in service (tank cleaned).

Christopher Whalen, Logan Township MUA Superintendent indicated “The entire project team; CTS, Sauereisen, and Aulffo Painting were all very helpful and responsive, resulting in a successful project with no issues.” The structure was inspected by Sauereisen and Logan Township MUA six months and 1.5 years after being returned to service and it is exhibiting superior performance. The coating is 100% fully intact with no indications of areas of concern. It continues to be washable and serviceable and will be periodically monitored to ensure its longevity. “The coating looks to be holding up great. We will continue to check it, but to date we have no issues,” Whalen said.

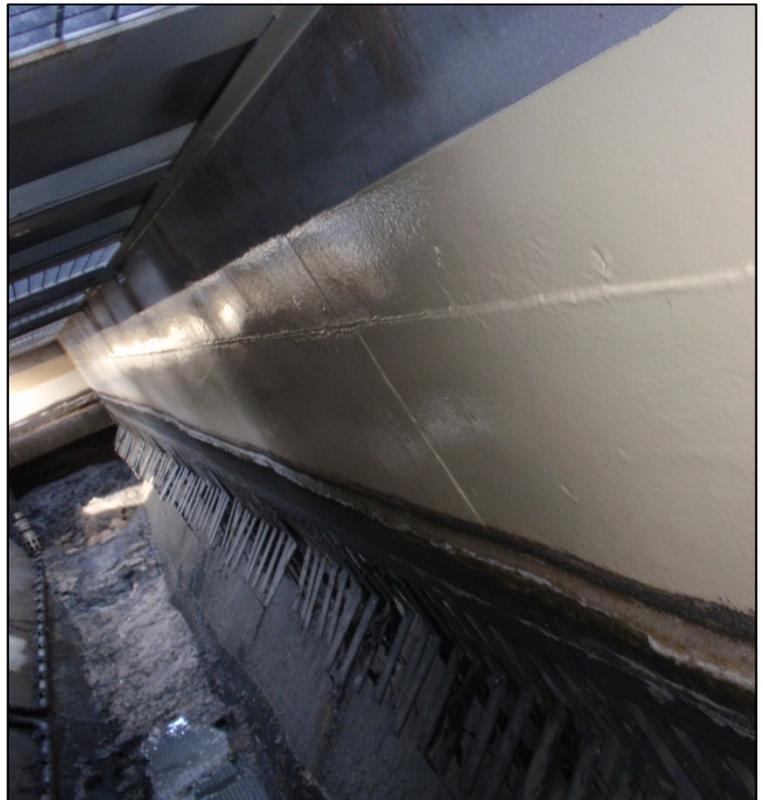
Figure 4 Coated stainless steel sidewall after six months in service (tank cleaned).
